## Aerial Thermal Infrared Survey of the Buranga Geothermal Prospect, Uganda

A drone-based aerial thermal infrared (TIR) and high resolution color imaging survey at the Buranga geothermal prospect in Uganda was completed in 2018 to facilitate safe access for exploration programs, constrain structure and shallow aquifer mapping, support heat flow estimates and provide environmental baseline imaging. About 2000 thermal images were captured by a drone over a period of 3 days and compiled to produce a 0.8 km<sup>2</sup> georeferenced, temperature-calibrated thermal orthophoto map with a pixel width of about 13 cm and positional error under 3.5 m. The complementary visible light color orthophoto map had a pixel width of 2.5 cm. High-resolution imaging was required for the survey because the wetland vegetation of Buranga would otherwise obscure the numerous small hot spring vents that are characteristic of the prospect. The TIR imaging was correlated with over 75 shallow temperature measurements made with ground probes in order to validate the completeness of the ground mapping and support the interpretation of the TIR imaging with respect to temperatures 10 to 30 cm below the ground su

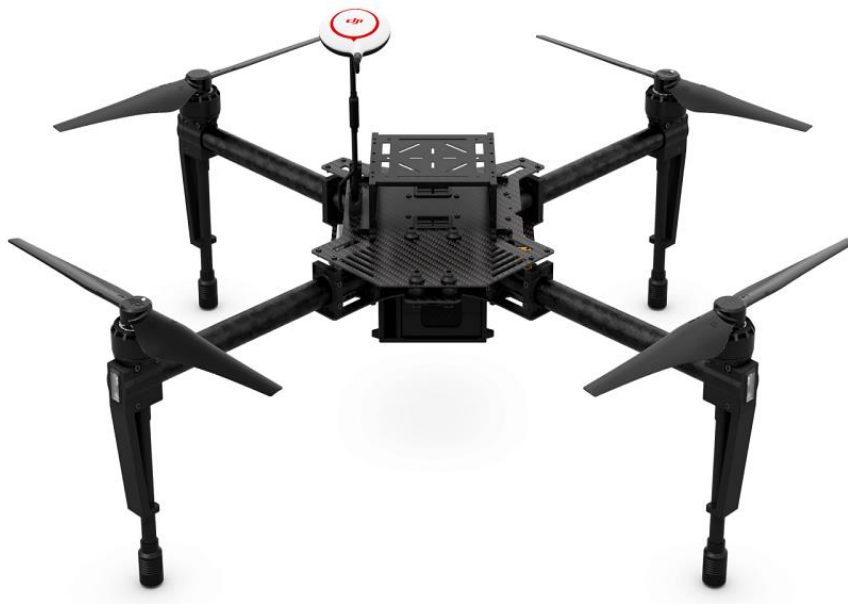
**Figure 4: DJI Matrice 100 quadcopter.**

For the UAS surveys, imagery was collected using a DJI Matrice 100 quadcopter (Figure 4). For TIR, the quadcopter was fitted with an ICI 640x480 uncooled TIR sensor (spectral response 7-14 $\mu$ m) with automated image capture. A Canon S100 point and shoot camera was fitted for normal visible (RGB) and DSM outputs.

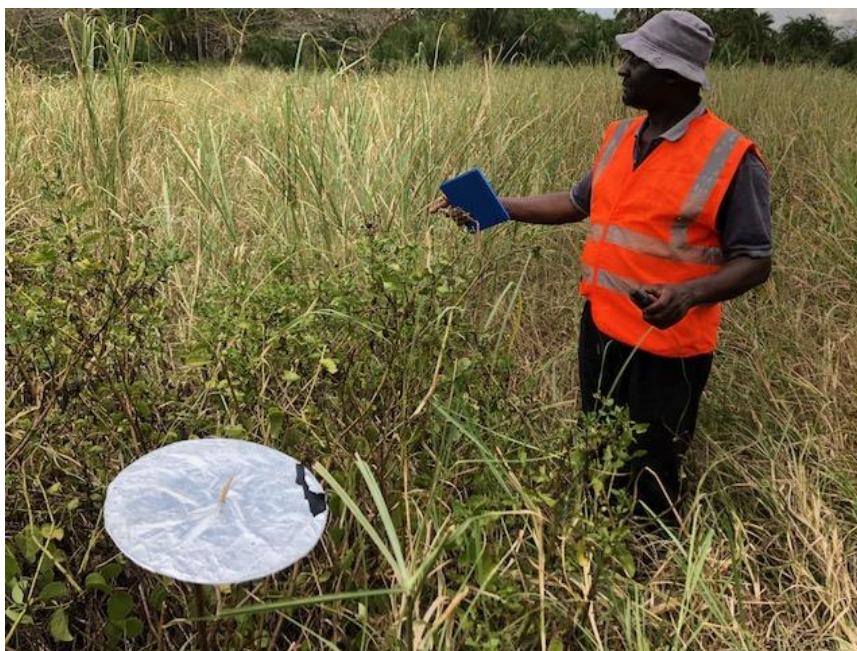
**Figure 5: GCP made from a 12” vinyl record covered with aluminium foil.**

To calibrate the georeferenced aerial data, 15 ground control points (GCP) were established prior to flight by placing reflective markers throughout the planned survey area. These were made from 12-inch vinyl records covered with aluminum foil (Figure 5). The location of the GCP was recorded using a Trimble R1 handheld DGPS receiver. The accuracy of the DGPS was 3 – 4 m at Buranga. An appropriate flight plan was determined using UgCS software based on the target area of interest (Figure 6). The flight plan was then uploaded to the quadcopter's flight controller. Accordingly, both in-flight navigation and image capture were autonomous.

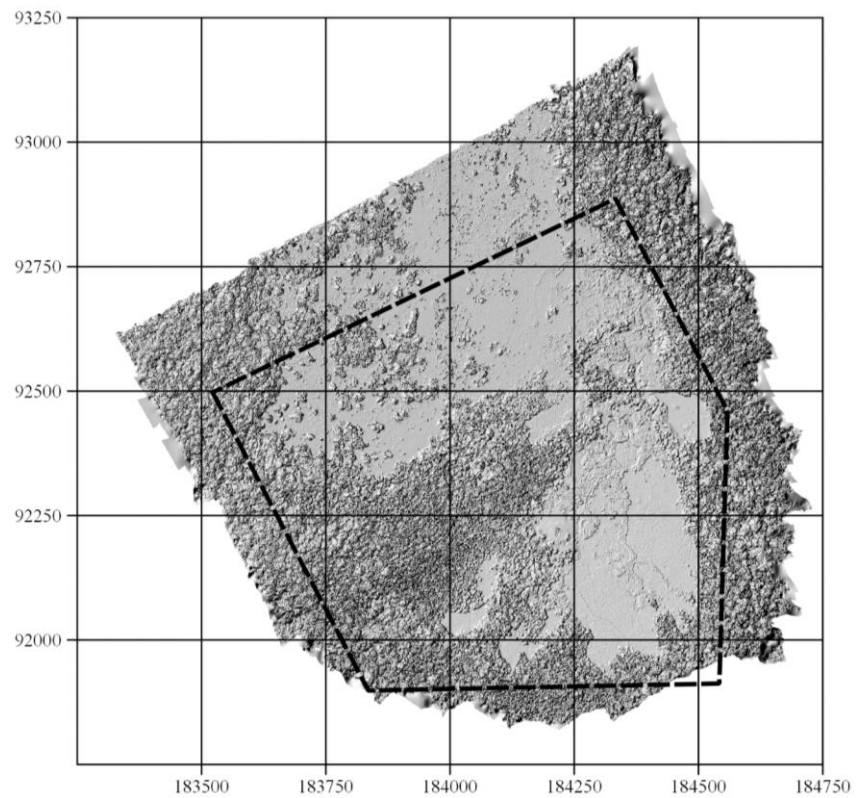
**Figure 7: Digital surface model (DSM). Map Datum WGS84. Note: Black dash line shows survey target area.**

For the visible imagery and DSM, 3 flights were made between the 22<sup>nd</sup> and 24<sup>th</sup> February 2018. Flight conditions were partly cloudy, with a maximum wind speed of ~20 km/h. The total flight time was about 45 minutes, providing 1430 images. Computer post-processing of imagery took about 20 hours, providing 15 orthophoto tiles and DSM with a total coverage of 1.2 km<sup>2</sup>, and orthophoto ground resolution of 2.5 cm (pixel width) (Figure 6 - Figure 7). The GCP allowed improved georeferencing of the orthophoto and gave an estimate of the positional error (x-axis 3.5 m, y-axis 2.0 m and z-axis 5.1 m). For TIR imagery, 6 flights were made between 22<sup>nd</sup> and 25<sup>th</sup> February 2018. Flight conditions were partly cloudy and mild (20 - 26°C), with a maximum wind speed of ~5 km/h (morning wind speed was lower than at midday). The total flight time was about 90 minutes, providing 2216 TIR images. Computer post-processing of imagery took about 5 hours, providing a single TIR orthophoto with a total coverage of 0.84 km<sup>2</sup> and ground resolution of 13.2 cm (Figure 8 and Figure 9).
